## Contaminated Soils Removal Progress Report

Clarence Valley Council Depot

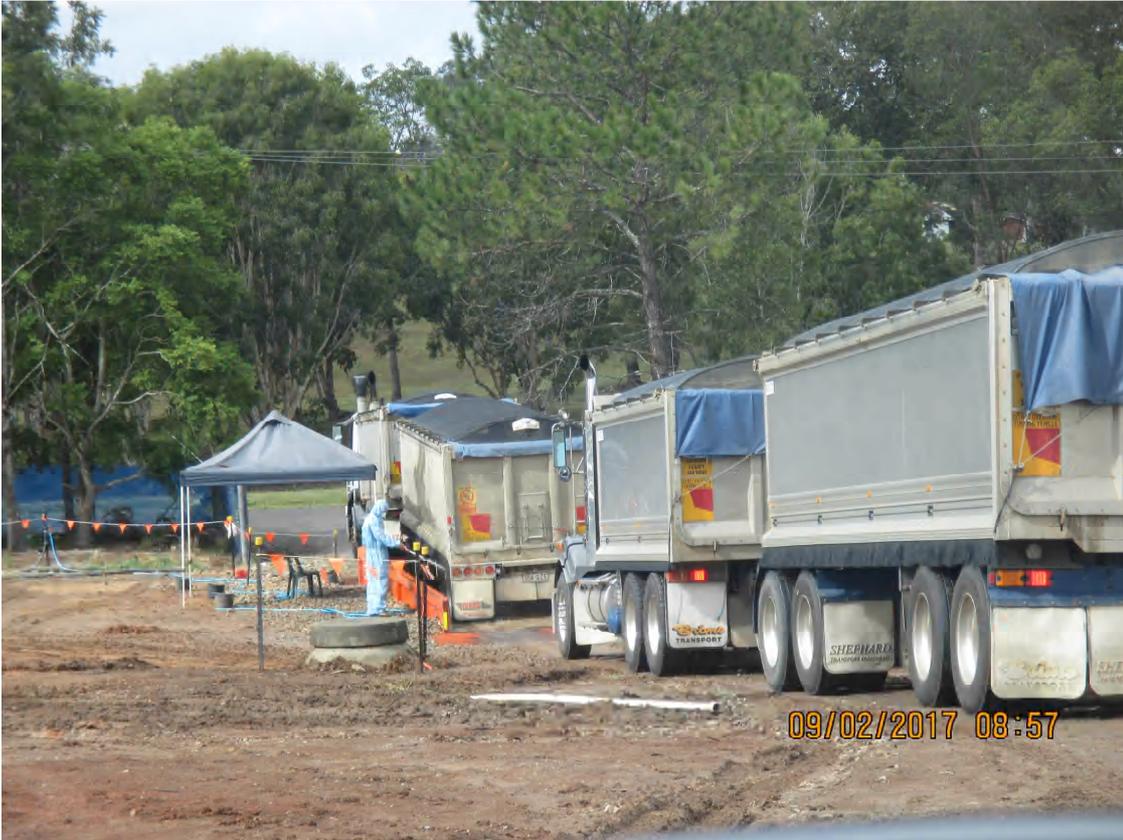
### **Truck Wash:**

All trucks are required to be decontaminated prior to leaving site, they are hosed, cleaned and pass through a wheel wash.

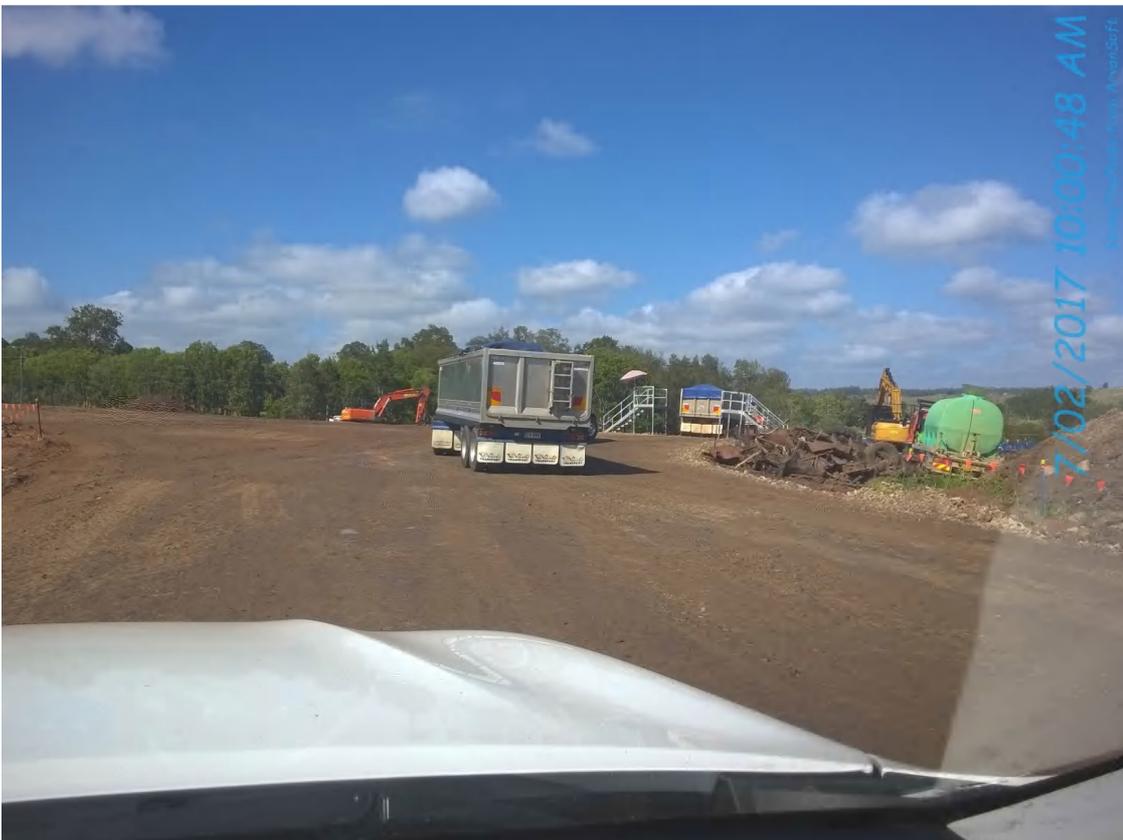
Site Haulage Roads – All Weather

Onsite watering is conducted continually; one water truck is allocated to the general site, whilst another operates at source of contaminated soils removal. Continued inspections have ascertained that over the past two months and there has been no evidence of any dust plumage. All weather haul roads were constructed mitigating dust creation by the trucks traversing through site.

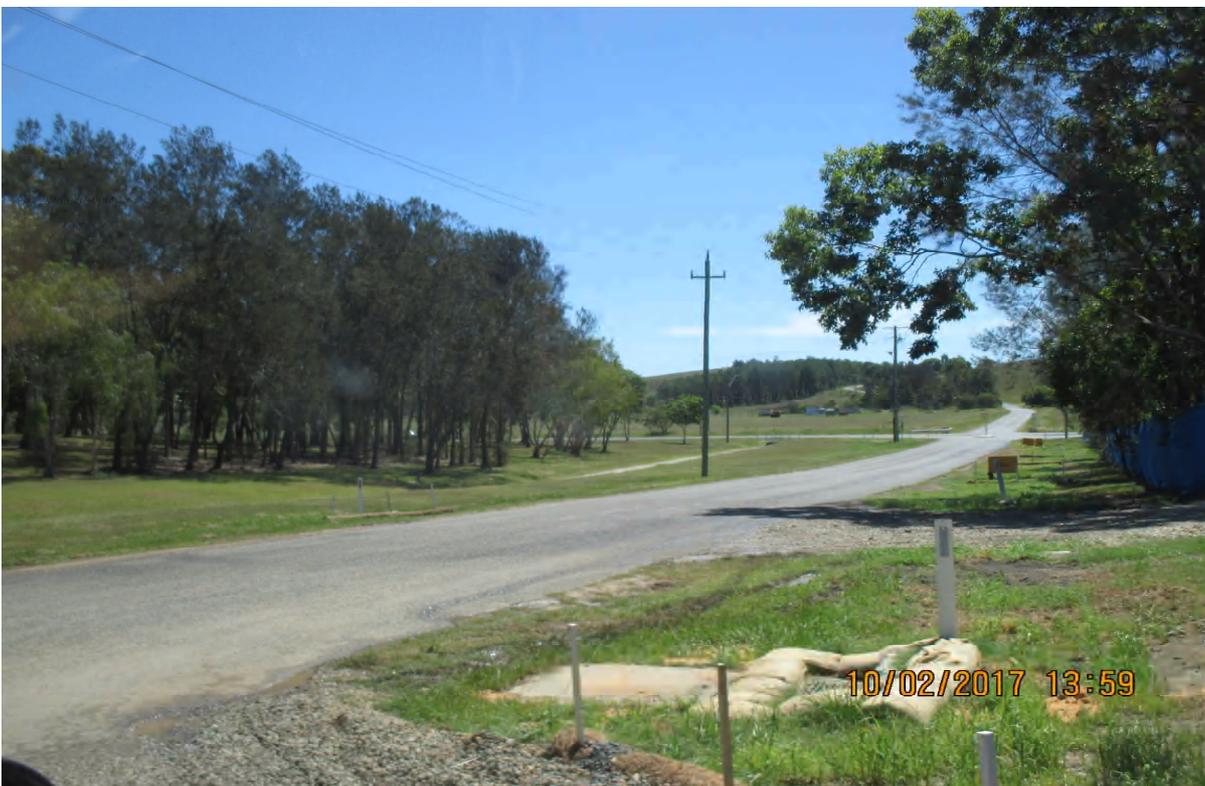
Public roadway condition:

Tyson and Skinner Streets are being washed down daily on numerous occasions as required.

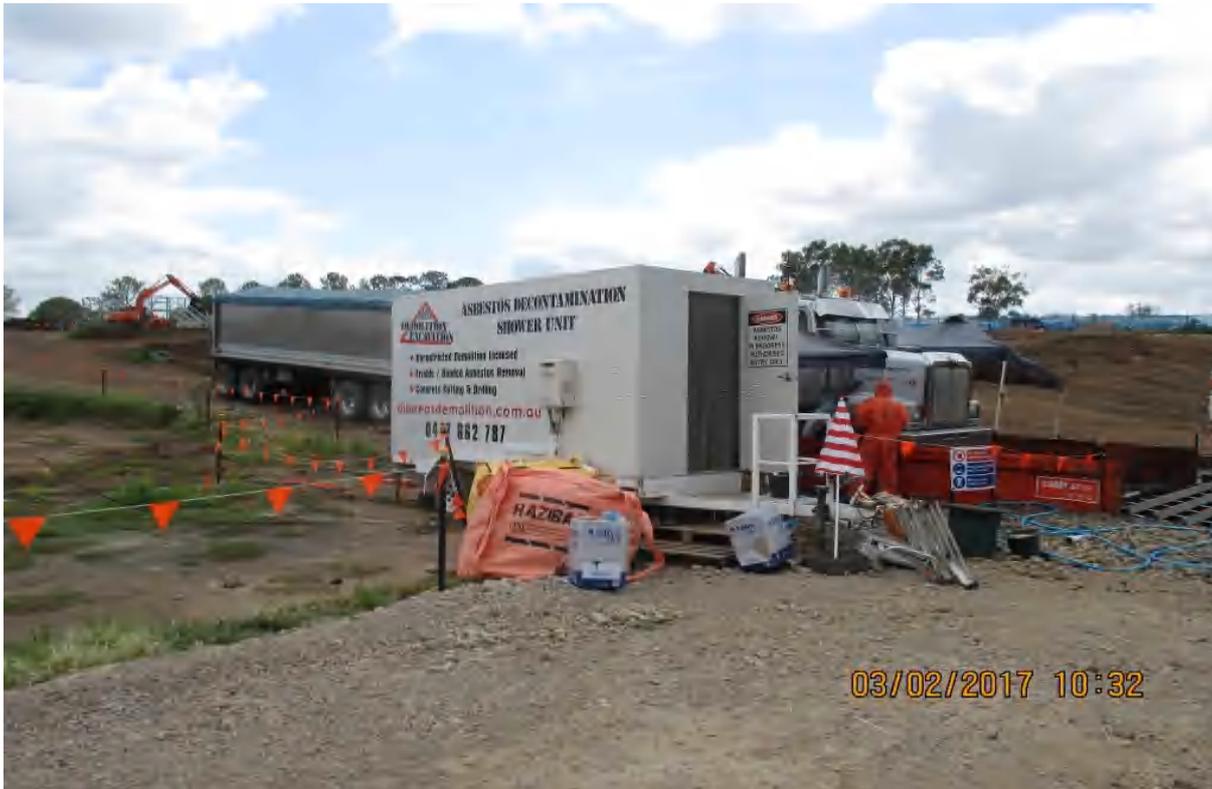
### Personnel Decontamination Unit:

A Decontamination Unit has been implemented to allow site personnel the ability to decontaminate and place PPE on commencement and completion of works. The Asbestos Removal Supervisor is ensuring decontamination processes are being adhered to by the site personnel.
