Contaminated Soils Removal Progress Report

Clarence Valley Council Depot

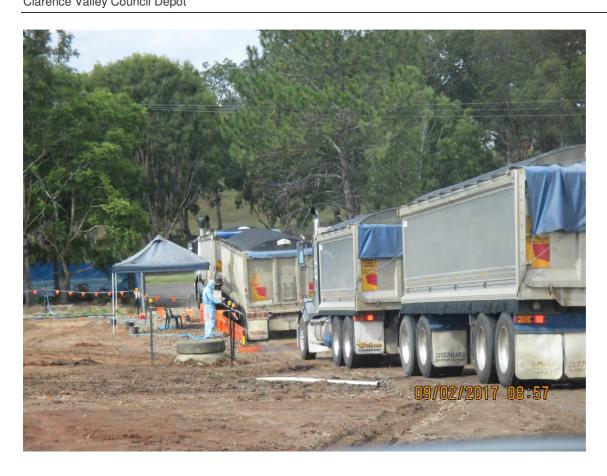
# Truck Wash:

All trucks are required to be decontaminated prior to leaving site, they are hosed, cleaned and pass through a wheel wash.

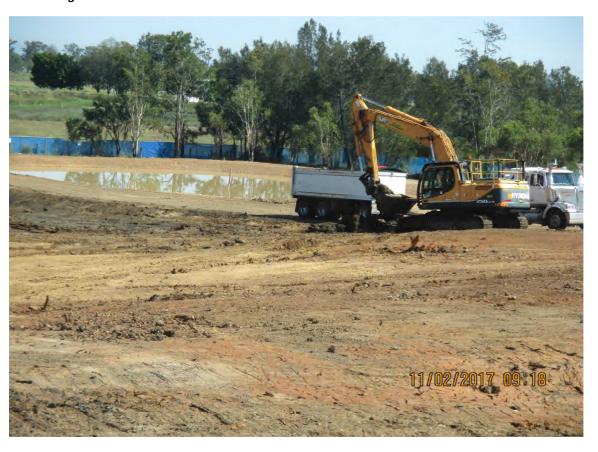
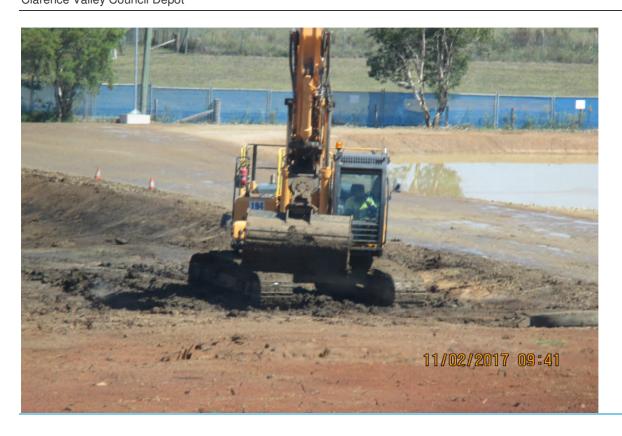
Site Haulage Roads - All Weather

Onsite watering is conducted continually; one water truck is allocated to the general site, whilst another operates at source of contaminated soils removal. Continued inspections have ascertained that over the past two months and there has been no evidence of any dust plumage. All weather haul roads were constructed mitigating dust creation by the trucks traversing through site.

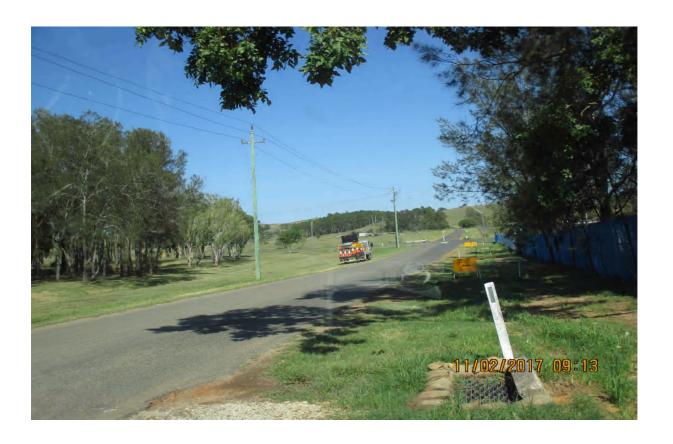
Public roadway condition:

Tyson and Skinner Streets are being washed down daily on numerous occasions as required.

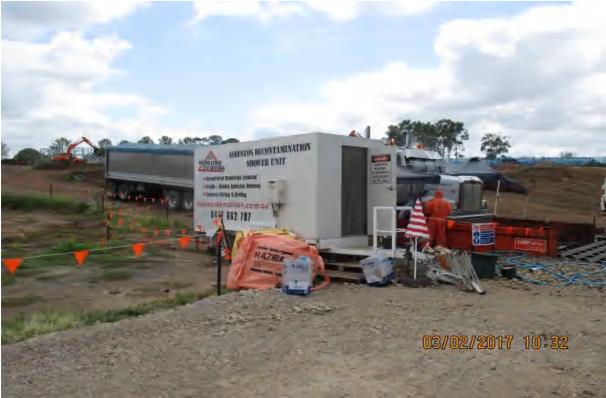
# **Personnel Decontamination Unit:**

A Decontamination Unit has been implemented to allow site personnel the ability to decontaminate and place PPE on commencement and completion of works. The Asbestos Removal Supervisor is ensuring decontamination processes are being adhered to by the site personnel.
