Contaminated Soils Removal Progress Report

Clarence Valley Council Depot

## 1. Introduction

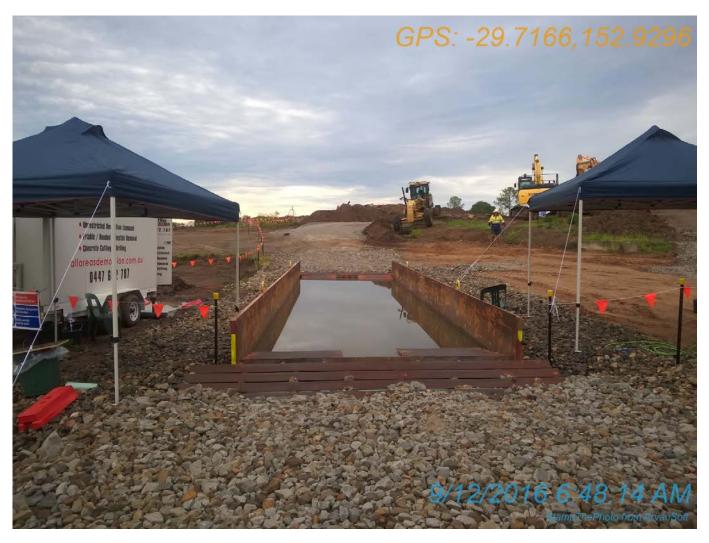
#### Truck Wash:

All trucks are required to be decontaminated prior to leaving site, they are hosed, cleaned and pass through a wheel wash.

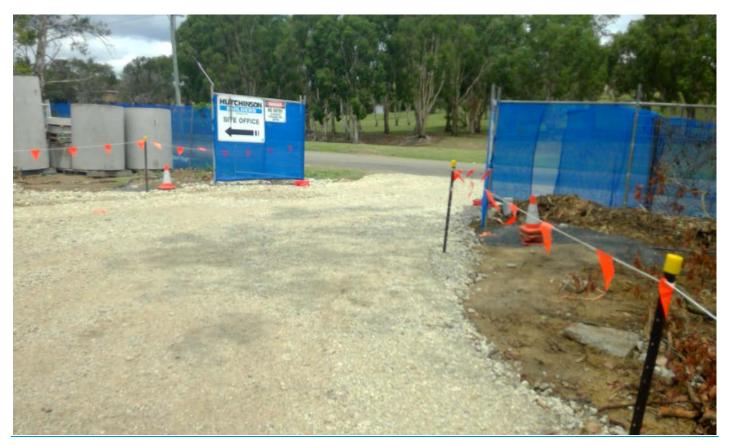
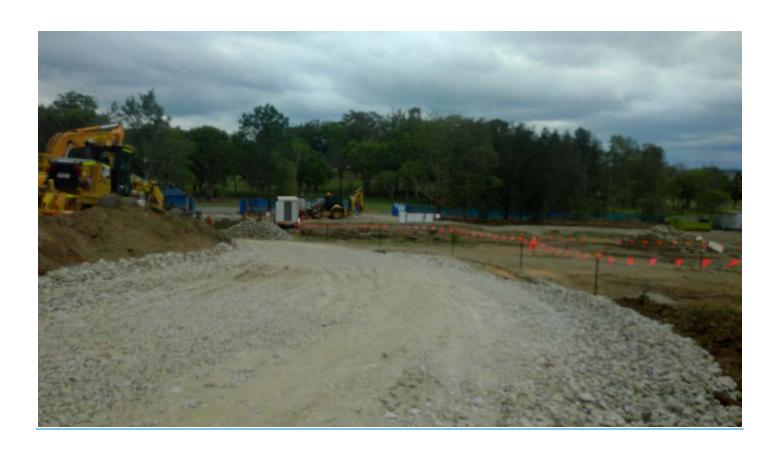
Site Haulage Roads - All Weather

Onsite watering is conducted continually, one water truck is allocated to the general site, whilst another operates at source of contaminated soils removal. Continued inspections has ascertained that over the past two days there has been no evidence of any dust plumage. All weather haul roads were constructed mitigating dust creation by the trucks traversing through site.

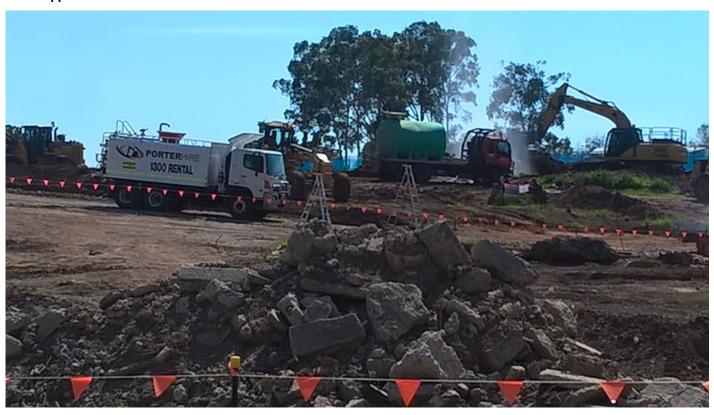
#### **Dust Suppression:**

Watering is also being conducted on the school boundary, site personnel are required to sign off daily prior to works commencement that sprinkler system is activated.

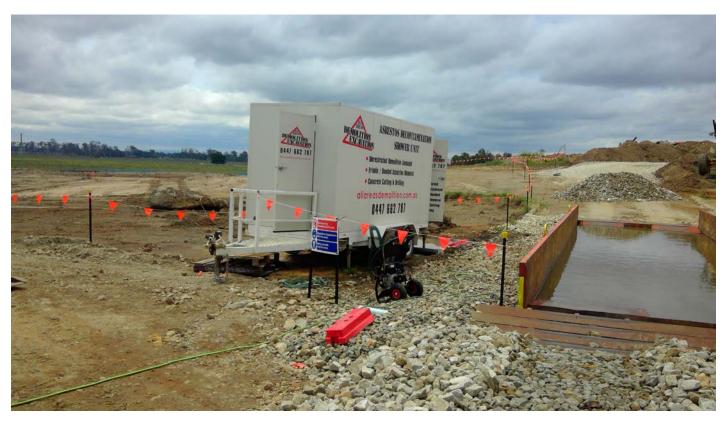
#### **Personnel Decontamination Unit:**

A Decontamination Unit has been implemented to allow site personnel the ability to decontaminate and place PPE on commencement and completion of works. The Asbestos Removal Supervisor is ensuring decontamination processes are being adhered to by the site personnel.
