Contaminated Soils Removal Progress Report

Clarence Valley Council Depot

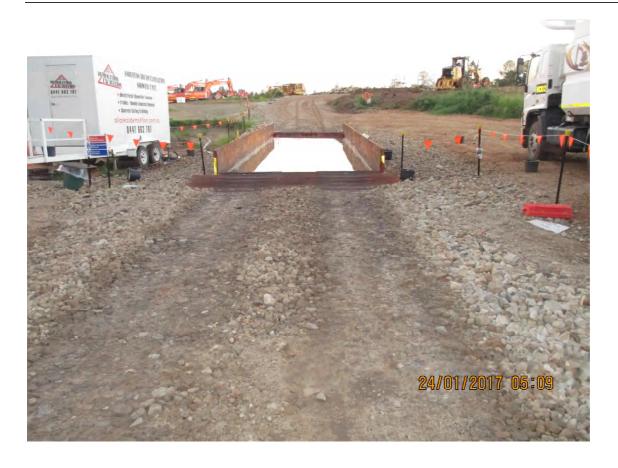
# Truck Wash:

All trucks are required to be decontaminated prior to leaving site, they are hosed, cleaned and pass through a wheel wash.

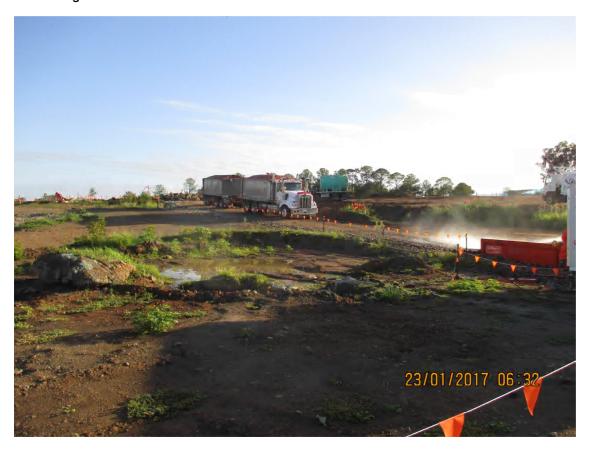
Site Haulage Roads - All Weather

Onsite watering is conducted continually; one water truck is allocated to the general site, whilst another operates at source of contaminated soils removal. Continued inspections have ascertained that over the past two months and there has been no evidence of any dust plumage. All weather haul roads were constructed mitigating dust creation by the trucks traversing through site.

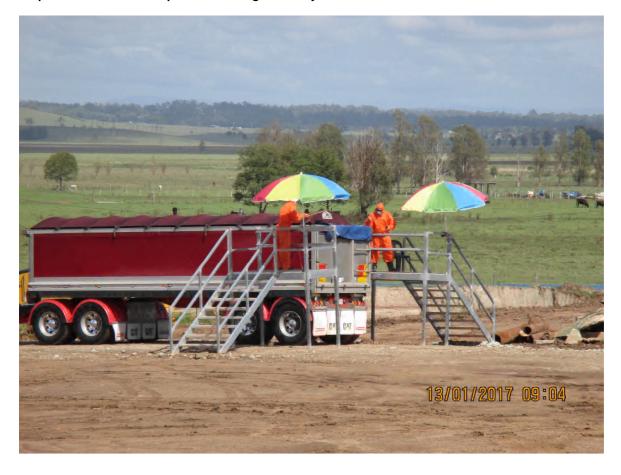
Tarp Tie down Procedure prior to entering wash bay:

- Hutchinson Builders and Lantrak representatives are inspecting all trucks leaving the site. Any trucks that are suspect of having tarp malfunctions are required to reverse, unload soil, decontaminate and leave site. No trucks are being permitted to leave site that are suspect of air pockets.
- No trucks are permitted to uncover their load at any time after leaving the CVC Depot site, until they reach the registered Swanbank landfill to dump.

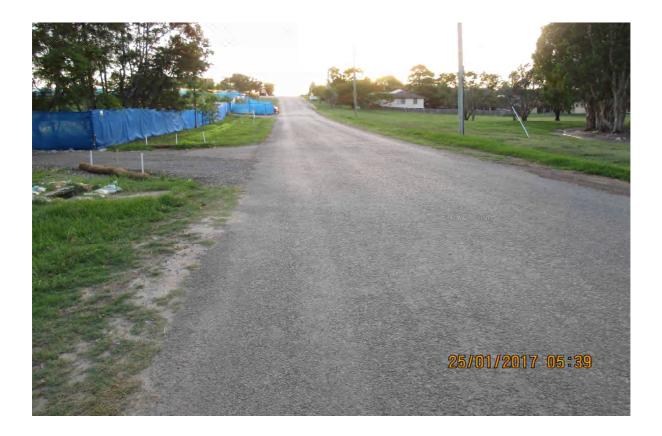
Public roadway condition:

Tyson and Skinner Streets are being washed down daily on numerous occasions as required.

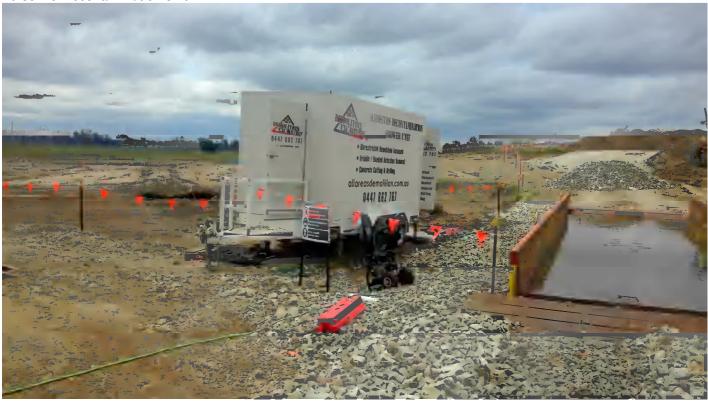
# **Personnel Decontamination Unit:**

A Decontamination Unit has been implemented to allow site personnel the ability to decontaminate and place PPE on commencement and completion of works. The Asbestos Removal Supervisor is ensuring decontamination processes are being adhered to by the site personnel.
